Document D6-19553

## Some Observations on the Stress-Corrosion Cracking of Three Commercial Titanium Alloys

J. C. Williams

The **BOEING** Company  
Commercial Airplane Division  
Renton, Washington

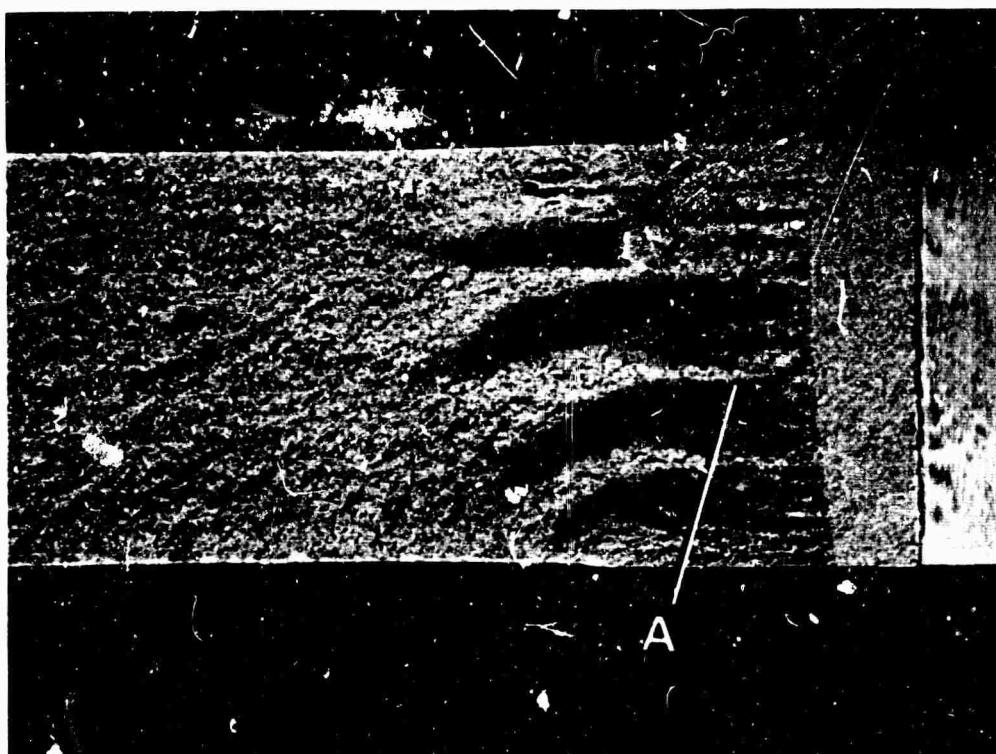
Fig. 1 Specimen Failed in 3½% NaCl Solution, Showing Fatigue Crack, Slow Crack Growth, and Fast Fracture Regions. Magnification: .3X

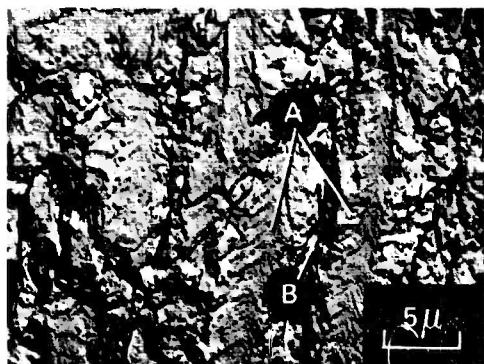
Replicas of the slow-growth regions of Ti-8Al-1Mo-1V and Ti-6Al-4V showed alternating regions of cleavage and ductile fracture as seen at A and B respectively in Fig. 2(a). Since no well-defined slow-growth zone was present on the fracture surface of the Ti-4Al-3Mo-1V, replicas were made adjacent to the fatigue precrack. Figure 2(b) shows that no cleavage fracture was evident in this alloy.

(a) *Alternating Regions of Cleavage and Ductile Rupture in a Ti-6Al-4V Specimen*

markings, such as shown at A in Figs. 2(a) and 4(a), are considered to represent successive positions of the crack front and have been shown to point in the direction of crack propagation since they point in the opposite direction to tear dimples in the adjacent ductile bands. Thus, the crack front lags behind at the alpha-transformed beta interface as if it were pinned, indicating that the beta or transformed beta regions retard crack propagation by acting as ductile inclusions. This result can be generalized for all alpha-beta alloys to predict that a reduced susceptibility for a given alloy will accompany either an increase in volume fraction or a more uniform dispersion of beta or transformed beta phase.

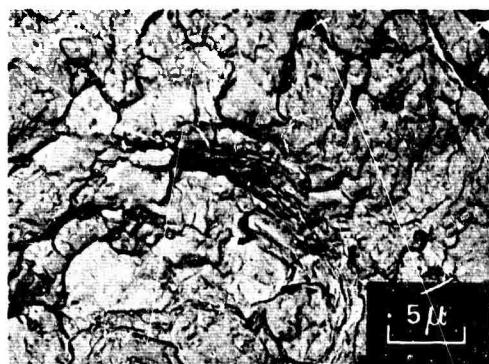
(b) *Ti-4Al-3Mo-1V Specimen Failed in 3½% NaCl Showing Absence of Cleavage*

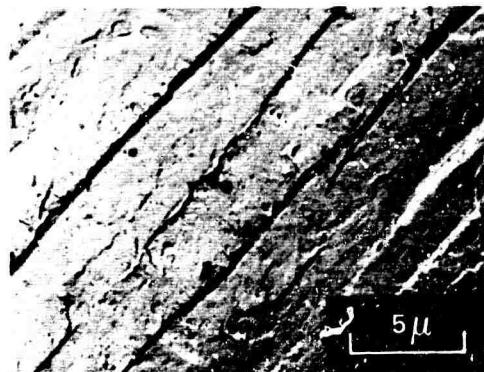
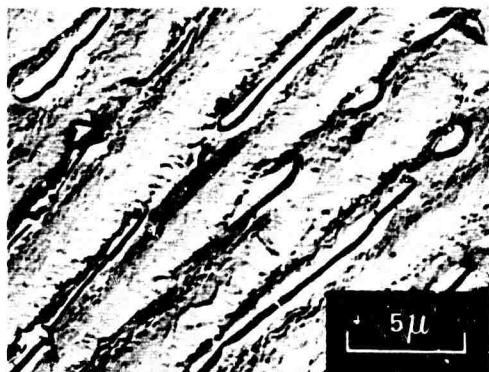
(a) *Electron Fractograph*

(b) *Electron Micrograph*

*Fig. 3 Ti-8Al-1Mo-1V Failed in 3½% NaCl Solution, Showing Correlation Between Microstructure and Fracture Topography*

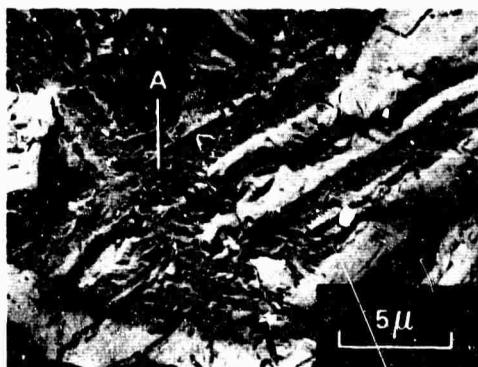
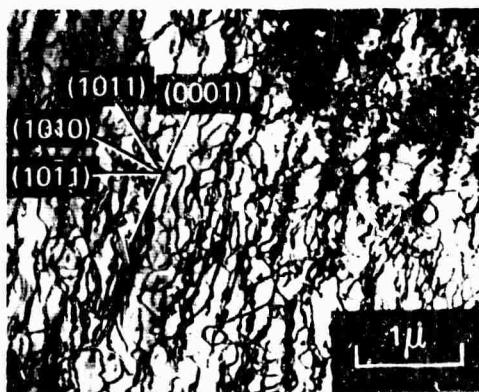
(a) Electron Fractograph

(b) Electron Micrograph

Fig. 4 Ti-6Al-4V Failed in 3½% NaCl Solution, Showing Correlation Between Microstructure and Fracture Topography

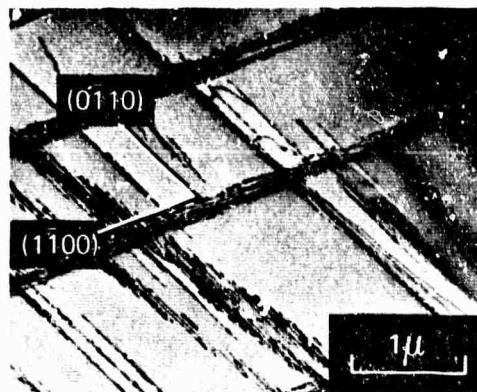
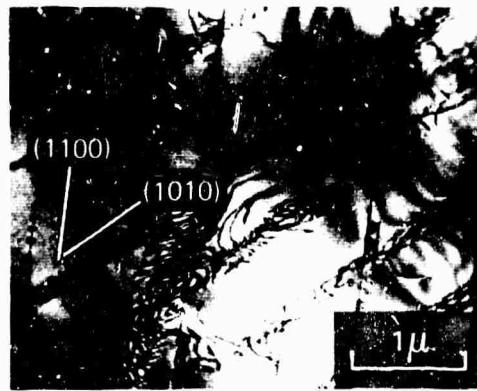
(a)  $Ti-4Al-3Mo-1V$ ,  $[1\bar{2}10]$  Zone Normal

(b)  $Ti-6Al-4V$ ,  $[\bar{1}\bar{1}23]$  Zone Normal

(c)  $Ti-8Al-1Mo-1V$ ,  $[\bar{1}\bar{1}23]$  Zone Normal

Fig. 5 Dislocation Arrangements After 3- to 4-percent Deformation

Considering the dislocation arrangements shown in Fig. 5, it is apparent that  $n$  is much larger for Ti-8Al-1Mo-1V and Ti-6Al-4V, since these alloys exhibit coplanar dislocation arrays and since, for a given strain, the dislocations are contained in fewer slip planes of principally the  $\{10\bar{1}\bar{0}\}$ -type. Thus, occurrence of cleavage failure in these alloys can be qualitatively explained if a minimum or threshold normal stress is required to promote SCC, since, by the previous arguments, the normal stresses in alloys that exhibit coplanar dislocation arrays will be greater. Conversely, ductile failure of Ti-4Al-3Mo-1V is indicative of normal stresses less than the threshold value. Such a threshold stress value does exist for titanium alloys since specimens loaded to less than a critical stress intensity<sup>1</sup> can sustain this load for prolonged times (more than 360 min) without failing. (2)

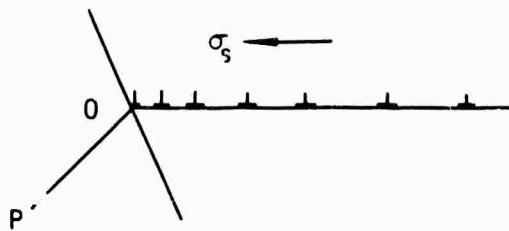
An expression for the normal stress at a dislocation pileup was derived by Stroh<sup>(8)</sup> who presented the following equation and Fig. 6:

Fig. 6 Dislocation Pileup at a Barrier (from Ref. 8)
